Engineering Field Trip Report

Friant Dam Enlargement

Study Team Field Trip Report

Upper San Joaquin River Storage Investigation Field Trip Logs

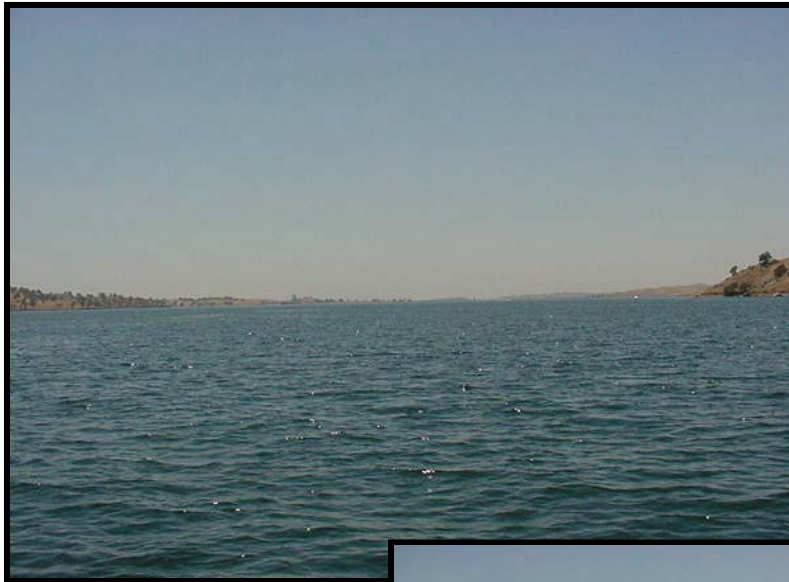
Friant Dam/ Lake Millerton –
Southwesterly view, toward
the dam.

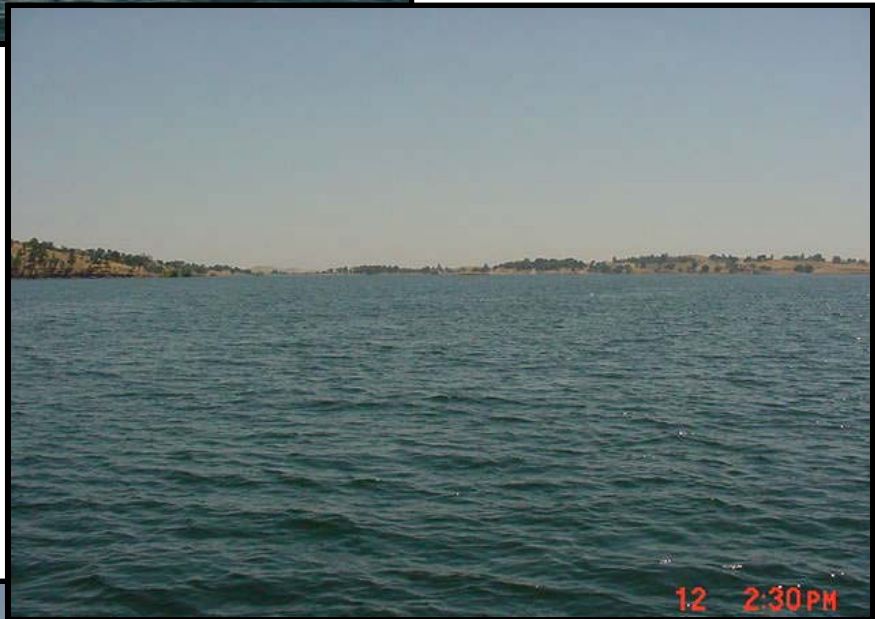
Southerly view of the low-lying
area east of the dam.

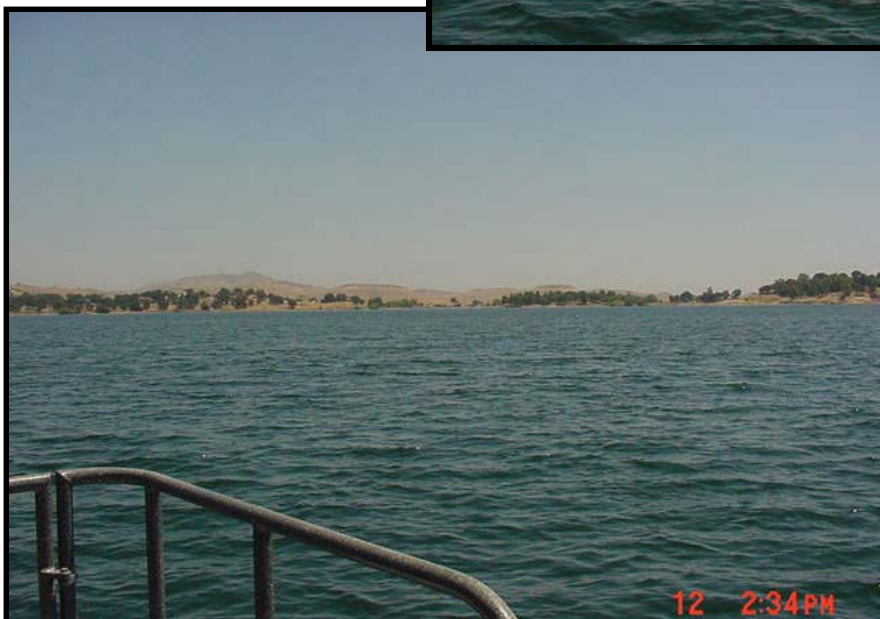
Southerly view of the low-lying
area east of the dam.

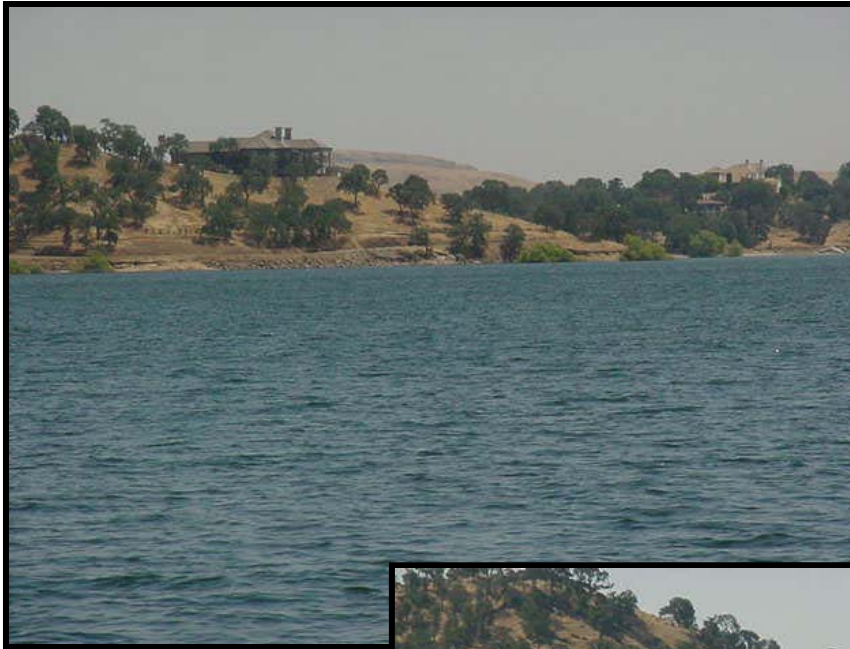
Southerly view of homes near shore just upstream of Winchell Bay.

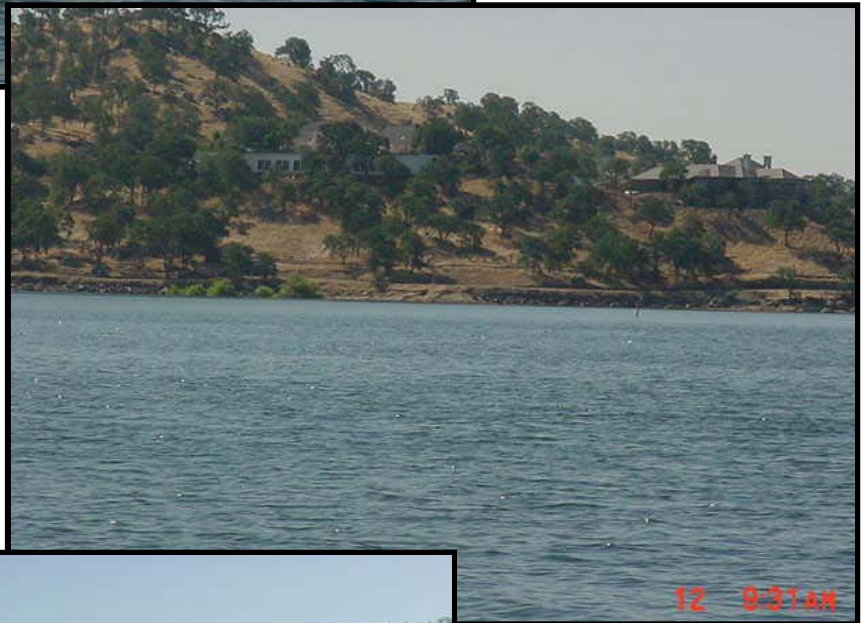
Southerly view of homes near shore upstream of Winchell Bay.

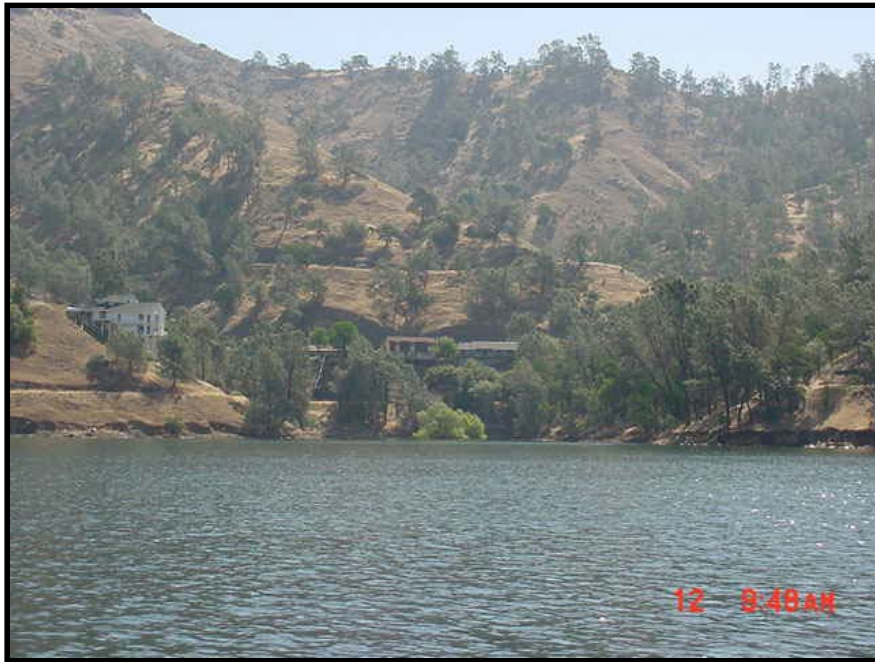
Northerly view of homes near shore downstream of Fine Gold.

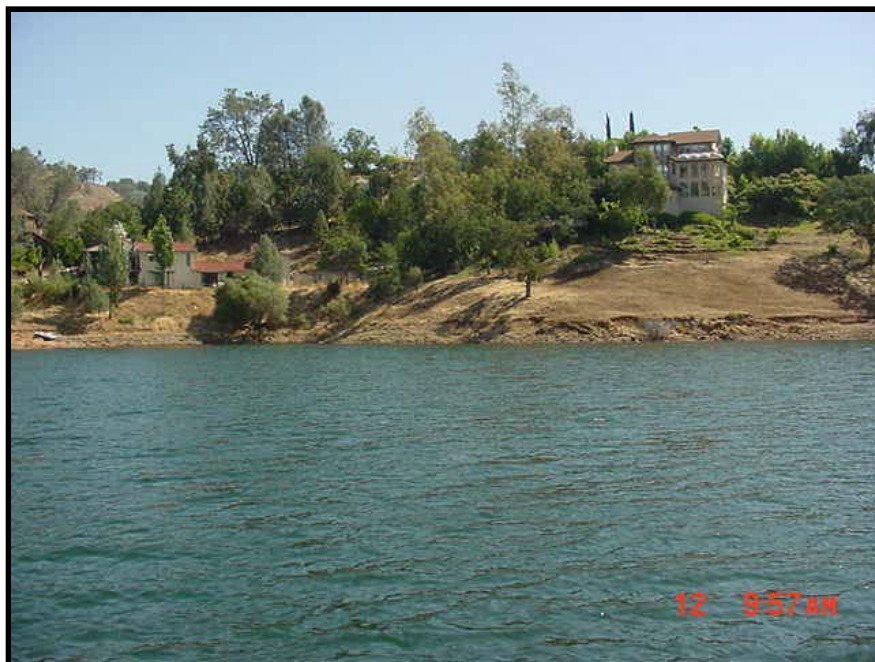
Northerly view of homes near shore downstream of Fine Gold. Lowest home on lake is at left.

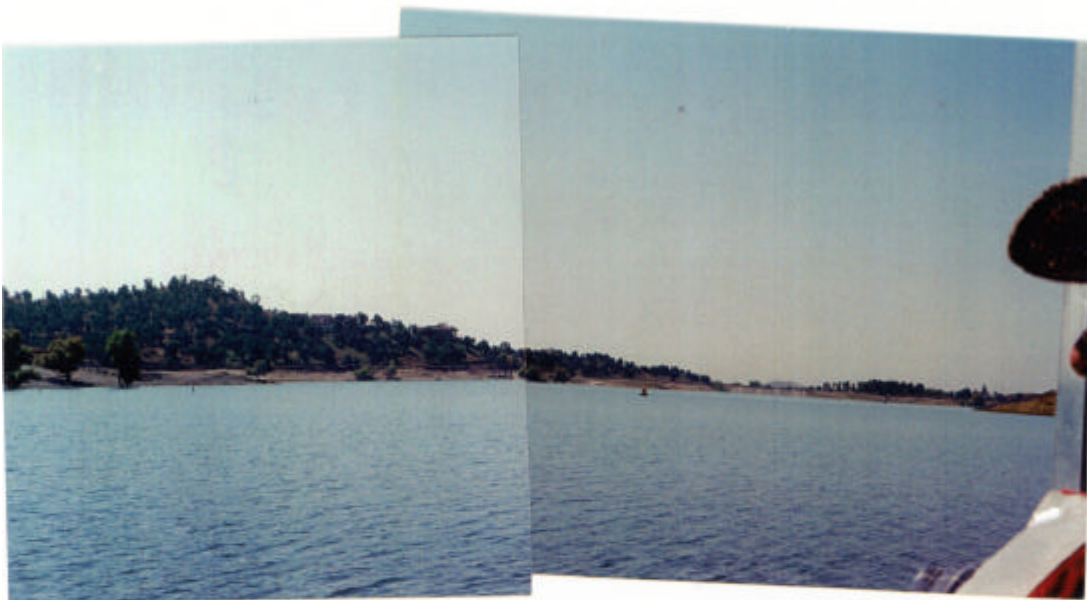
Photo 1

FRIANT DIKE AREA

View to the south of the low terrain extending south-southeast from the high ground immediately left (southeast) of the left abutment of Friant Dam to approximately 1.5 miles southeast of the dam. One of the California State Parks boat ramps is visible at right center. Raising Friant Dam would require that a dike be constructed in this low area along the reservoir rim.

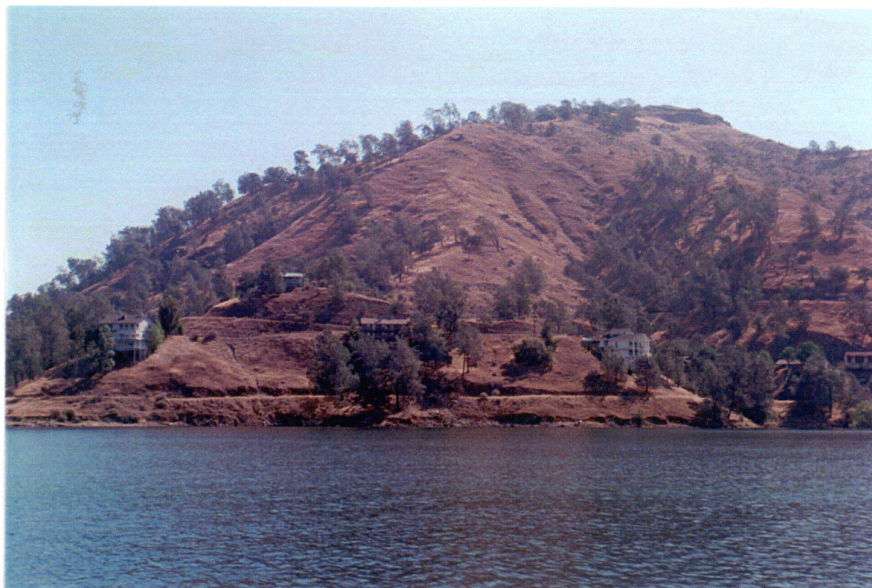
Photo 2

SKY HARBOR

View to the east of the community of Sky Harbor, located 4 miles upstream (northeast) of Friant Dam, with Pincushion Mt. in the background. Sky Harbor includes approximately 30 homes and is one of two residential communities located on the shoreline of Millerton Lake.

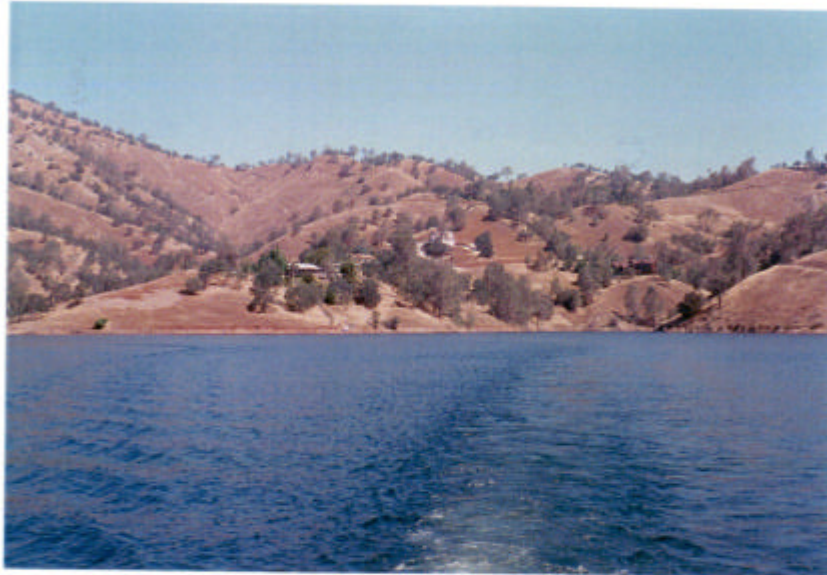
Photo 3

HIDDEN LAKE ESTATES

View to the north of the community of Hidden Lake Estates located 5 miles upstream (north) of Friant Dam. Hidden Lake Estates includes approximately 45 homes and is located immediately west of Fine Gold Damsite.

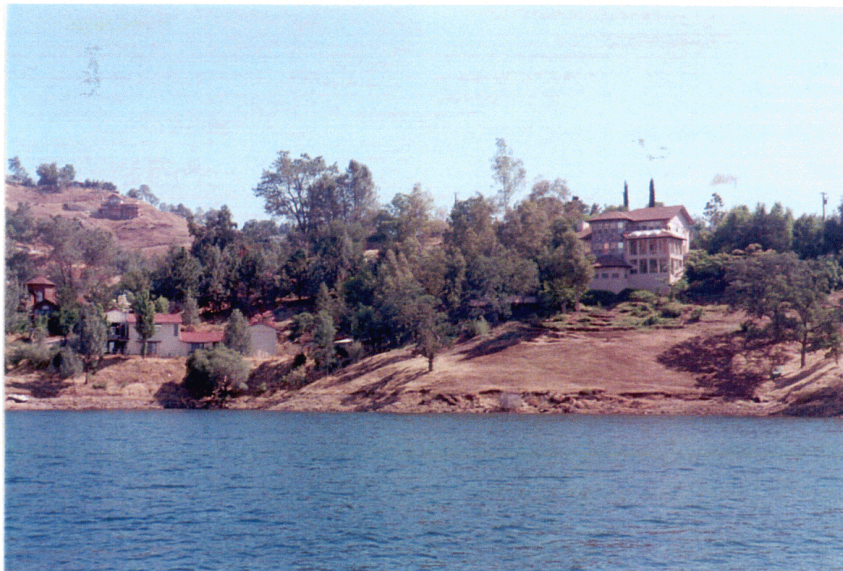
Photo 4

HIDDEN LAKE ESTATES

Closeup view to the north of homes in the community of Hidden Lake Estates. The home shown at lower left is at the lowest elevation of any home located along the Millerton Lake shoreline.

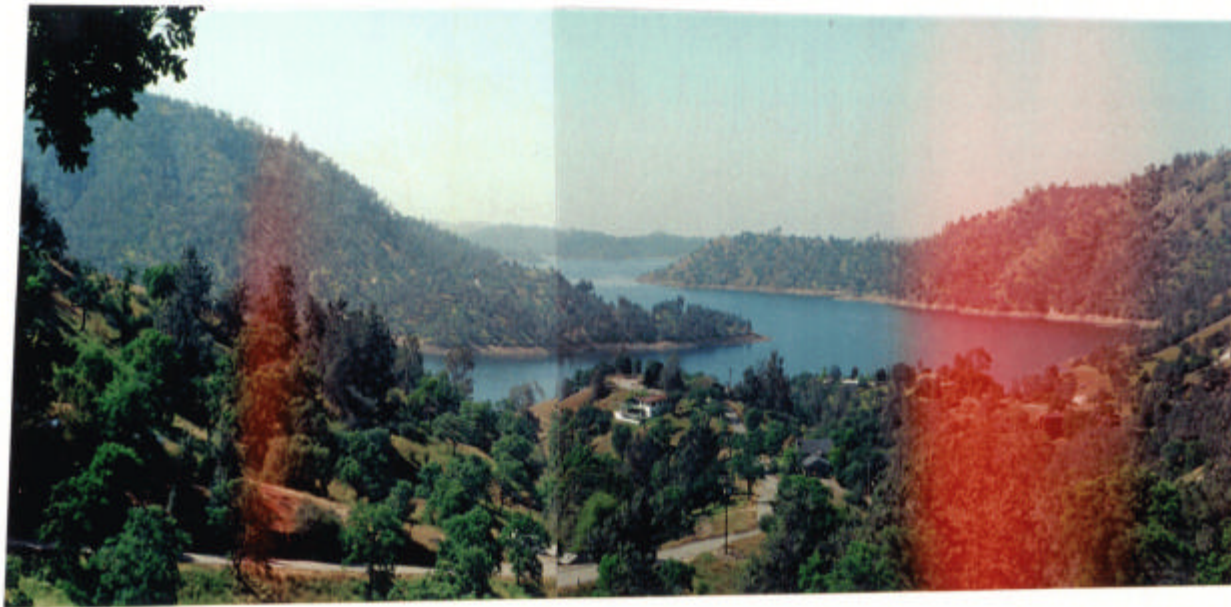
Photo 5

HIDDEN LAKE ESTATES

View to the south of the community of Hidden Lake Estates with Sky Harbor, Pincushion Mt. and Millerton Lake in the background.

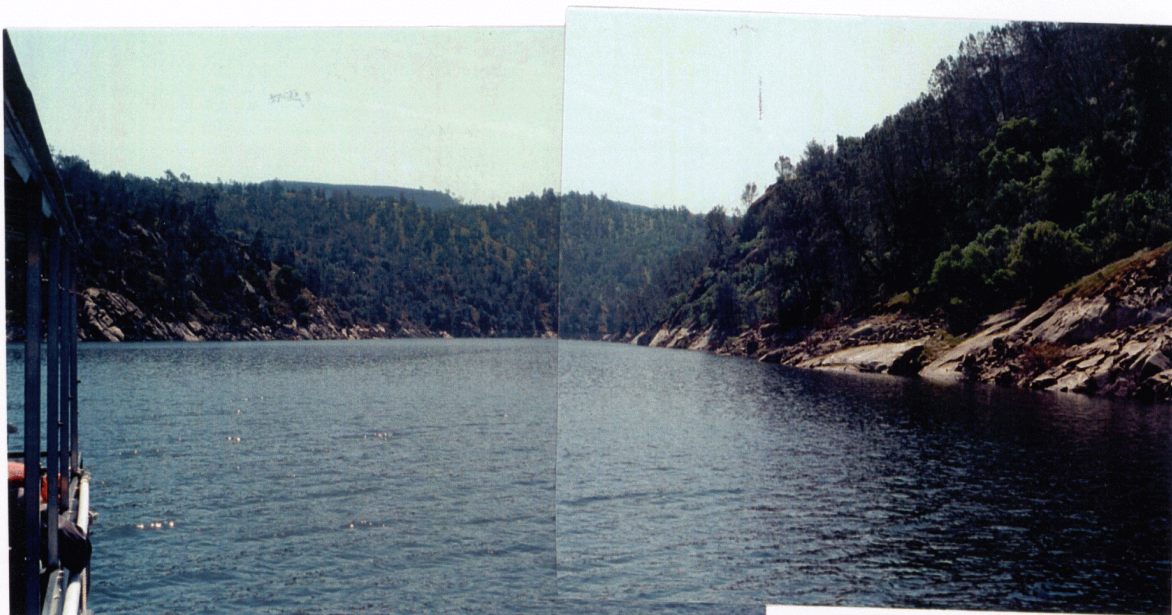
Photo 6

PINCUSHION DAMSITE

View upstream (southeast) of the dams site. Steep lower slopes expose hard, water-scoured moderately to slightly fractured granitic rock.

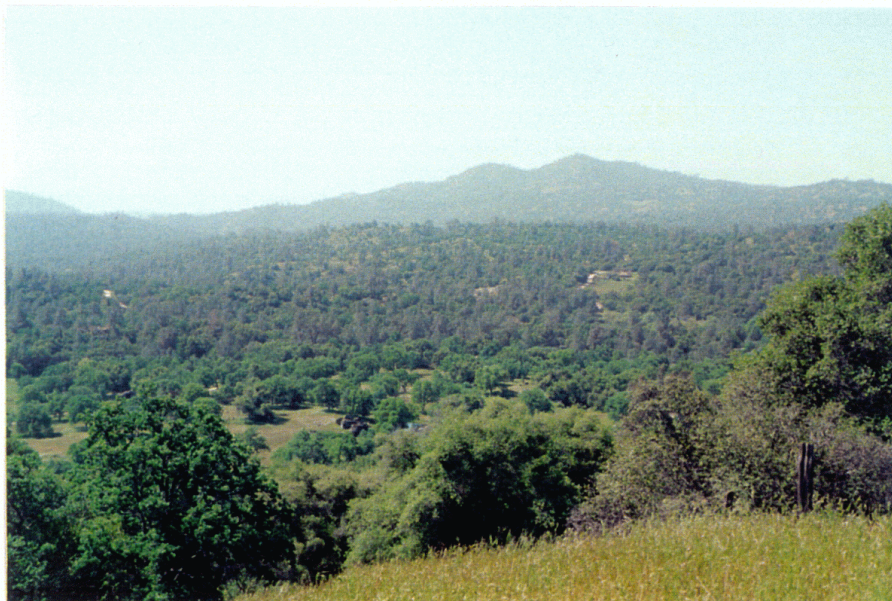
Photo 27

FINE GOLD RESERVOIR

Panoramic view to the southwest of the reservoir area. The highest peak in the background is Hulbert Mtn. (El.).

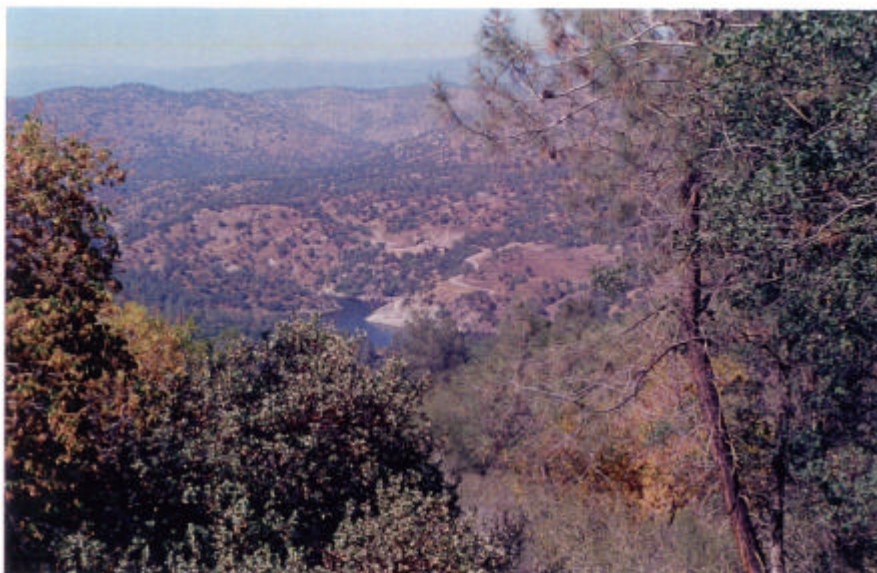
Photo 28

KERCKHOFF POWERHOUSE NO. 2

Panoramic view to the northeast of the San Joaquin River canyon from the road just south of Temperance Flat. Kerckhoff Powerhouse No. 1 and a waste berm are visible at photo center. The waste berm is composed of "tunnel muck" (mostly granitic rock fragments) that was produced by the excavations for the underground powerhouse and access tunnels.
